22-986564

Report of Survey

Kady Krogan 42

24 January 2022

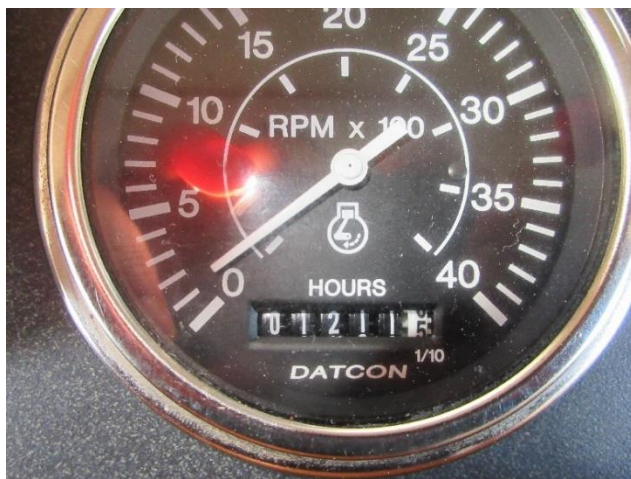
-Analog engine hour meter shows 01211.5 hours
