SAMS Marine Surveyor

Report of Survey

09 February 2021

Name of Vessel: xxxxxx **Date of Survey Inspection:** 09 February 2021
Vessel: 2001 Predator 35
Owner/Seller: xxxxxx
Report prepared exclusively for : xxxxxx
Address: xxxxxxxxx
Purpose of survey: pre-purchase
In Attendance: seller’s and buyer’s brokers, owners, engine and hull surveyors

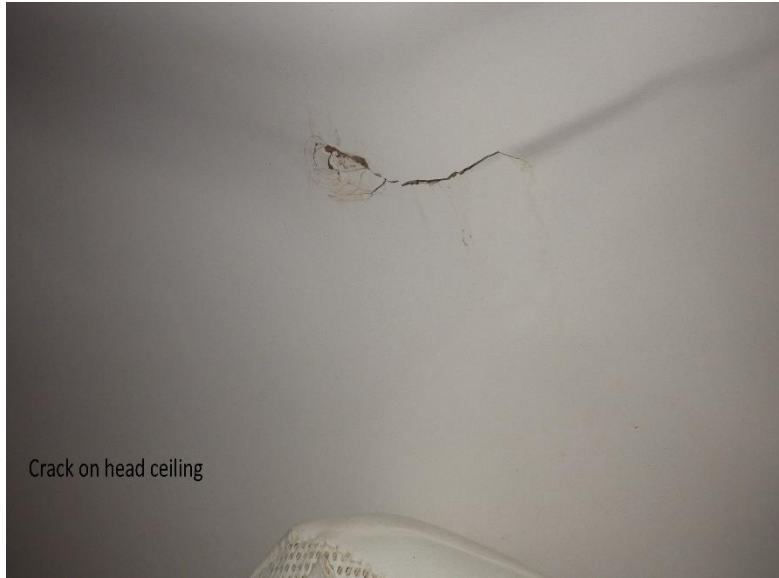
Crack on head ceiling

- 19. Cracking is noted on the head ceiling, this may have been caused due to the tuna tower. Investigate and repair or frequently monitor as deemed necessary.**

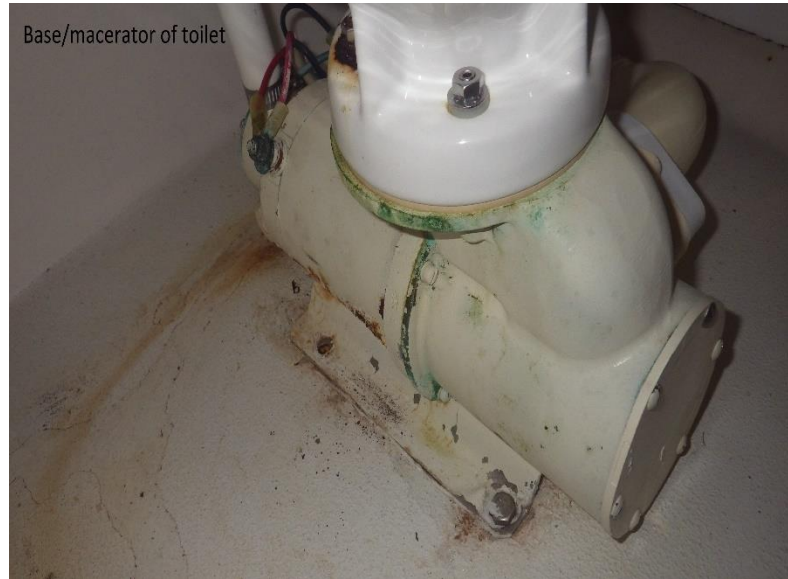
Base/macerator of toilet

14. The starboard engine water temp gauge appears to be in operative. (reads 110 degrees regardless of rpms) Repair.
15. The toilet leaks when flushed. Diagnose and repair or replace as necessary.

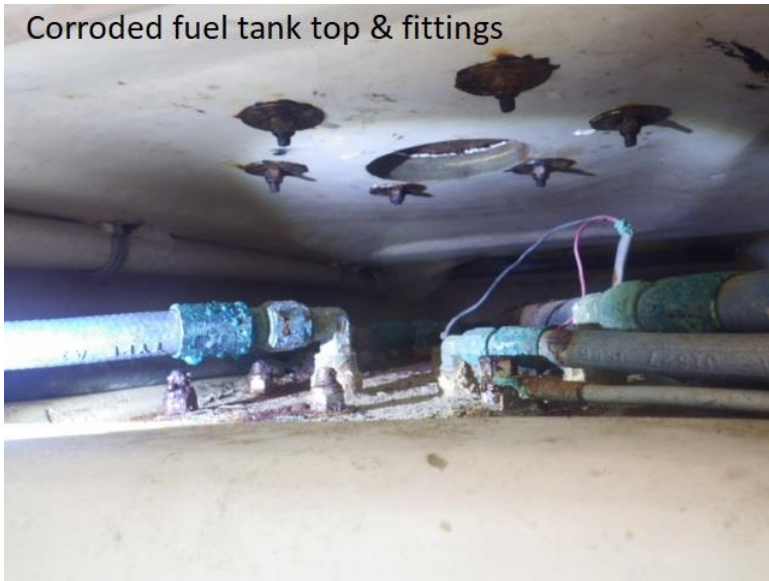
Corroded fuel tank top & fittings

- 2. The top of the main fuel tank and fuel line connections, hoses and fittings are rusted and in generally poor condition. Professional diagnosis and remedy is recommended.**

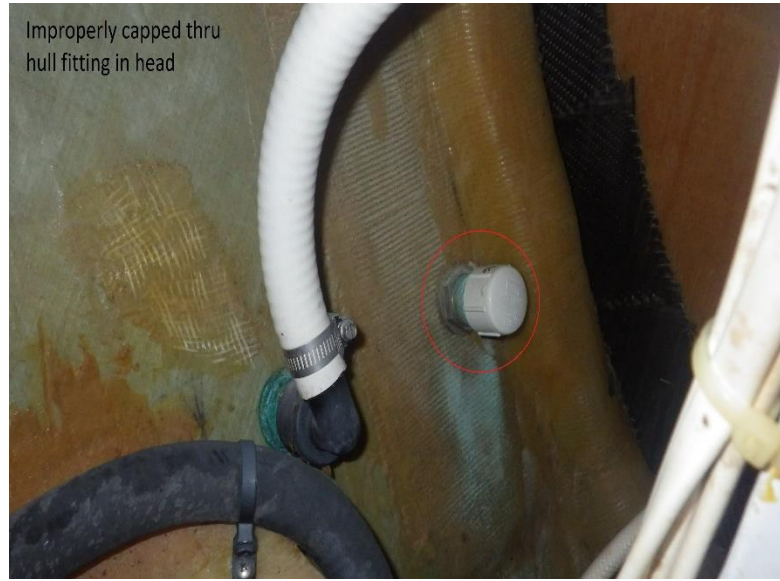
Improperly capped thru hull fitting in head

16. One metallic thru hull fitting on the interior topside, accessible thru the head cabinet is improperly capped with a plastic cap fitting. In addition, there is a thru hull on the starboard side of the engine compartment that is also capped with improper cap fitting. Metallic thru hulls should be capped with metallic fittings. Remove plastic components and replace with the proper galvanically compatible cap fittings.
