## **Report of Survey**

**11 March 2022**

**Vessel:**2008 Hatteras GT 60 Convertible

**Purpose of survey:** insurance

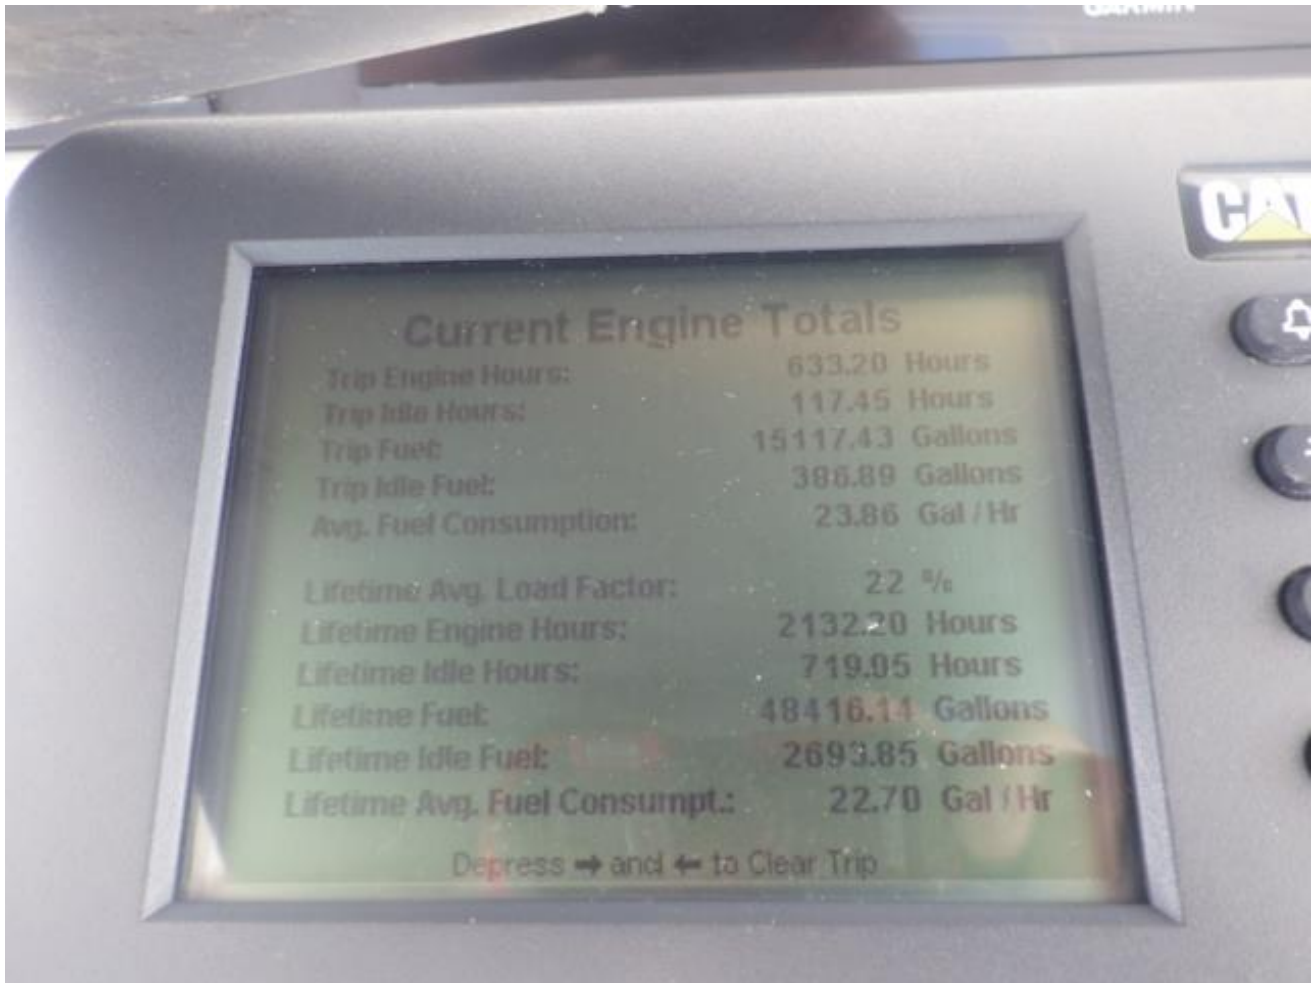
-Caterpillar digital engine status meters show:

**2132.20 engine hours port, and 2131.80 engine hours**

- Lifetime fuel consumption: 4816.14 gallons total
