Report of Survey
2016 Invincible 39
18 February 2020

Name of Vessel: Good Times

Vessel: 2016 Invincible 39' w/ triple Yamaha 350 outboards

Purpose of survey: insurance

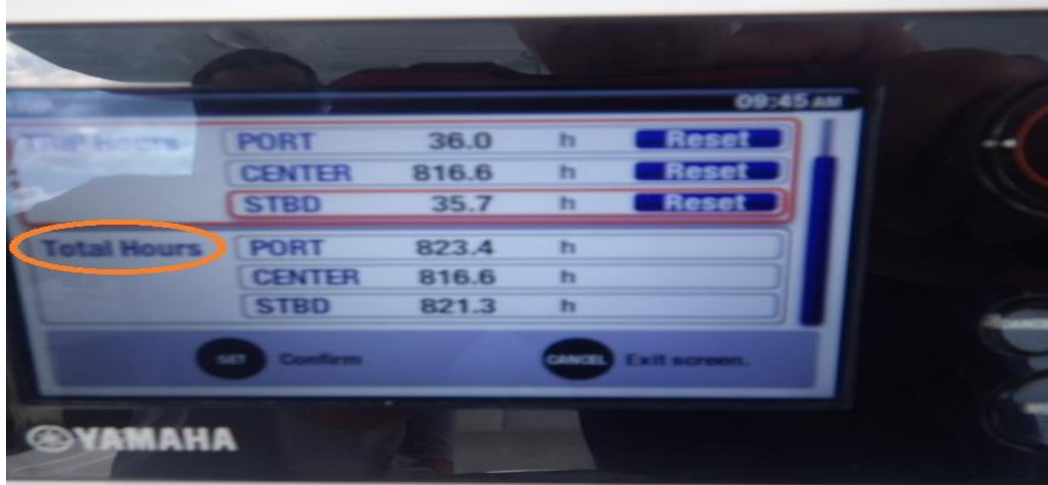
The engines were operated during survey. From external examination, the engines appear to be in good condition.
Digital engine hour display shows 823.4 hours port, 816.6 hours center, 821.3 hours Stbd.
